Construction joint

Drawing no.: DeckFloor-1209

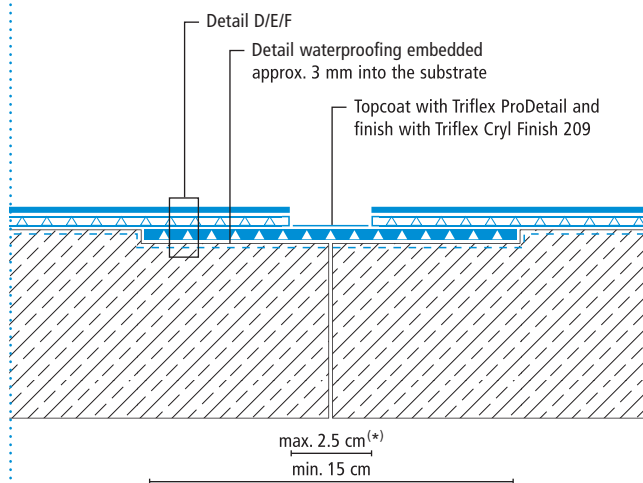
(*) Omission of surface coating and wearing layer (see system description)
